# CERCLA

## Preliminary Assessment Report

Illinois Environmental  
Protection Agency

The Insta-Foam site occupies an area of approximately nine acres on Broadway Street (U.S. Route 53) in the City of Crest Hill, Illinois in Will County. The property is bordered on the north by a 100 foot right of way of the main line of the Elgin, Joliet, & Eastern Railway company, on the east by Broadway Street (US Route 53), on the south by Chaney Avenue, and on the west by a residential housing area. The majority of land use to the north and east is industrialized or agricultural.

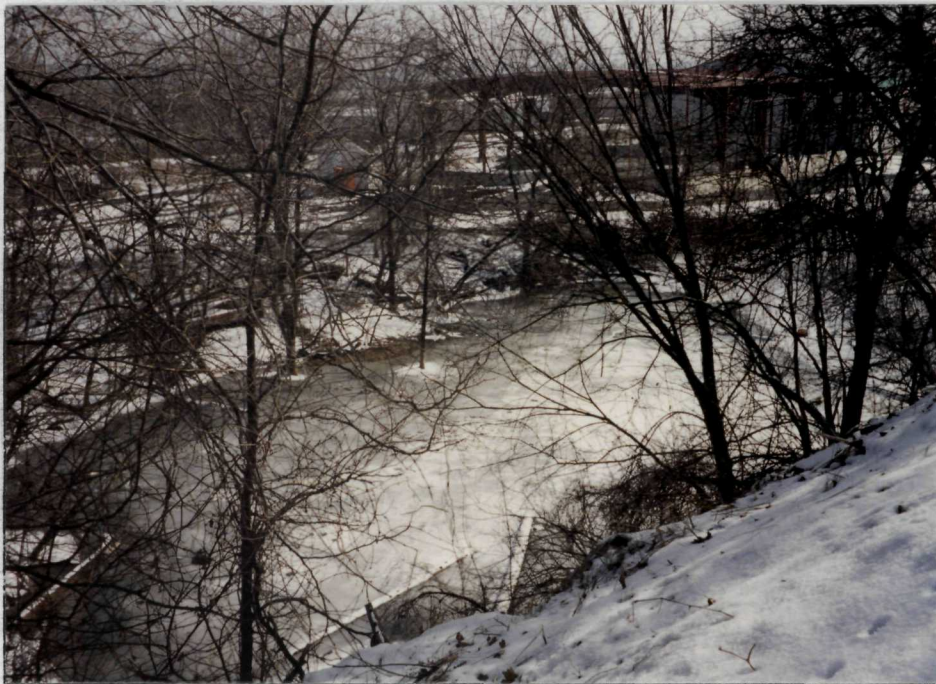
COMMENTS: PICTURE TAKEN TOWARD

East. On-site pond in

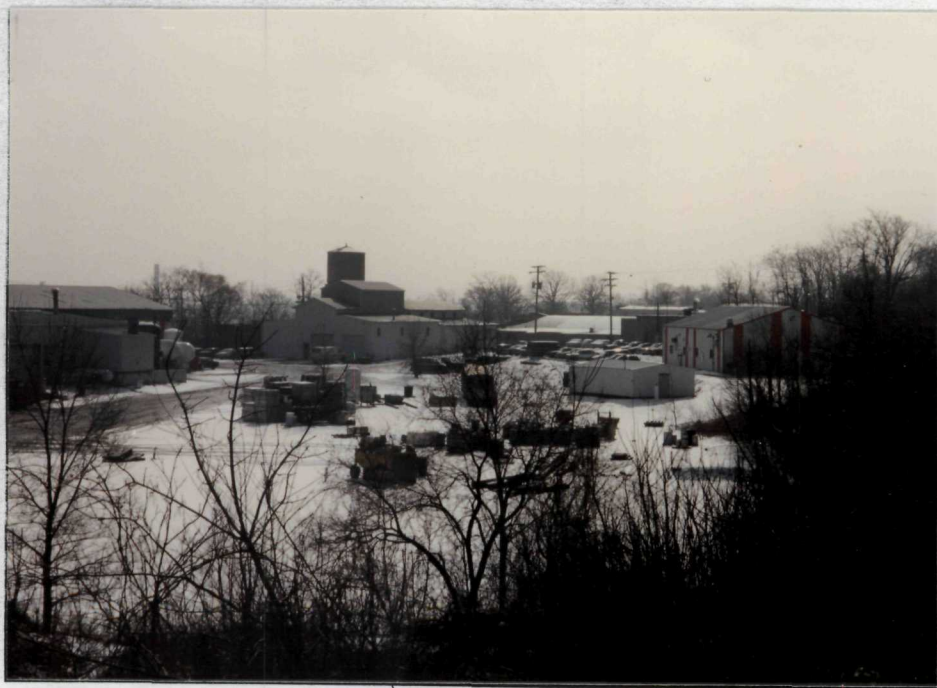
COMMENTS: PICTURE TAKEN TOWARD

Southeast. Main quarry area
